REPAIR, EVALUATION, MAINTENANCE, AND REHABILITATION RESEARCH PROGRAM

TECHNICAL REPORT REMR-CS-38

UNDERWATER STILLING BASIN REPAIR TECHNIQUES USING PRECAST OR PREFABRICATED ELEMENTS

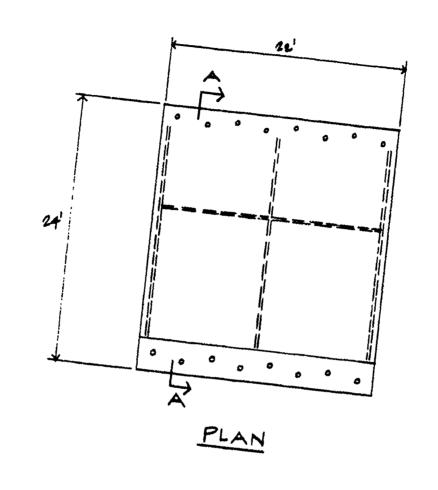
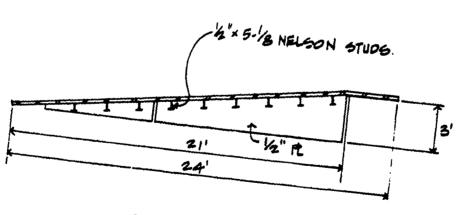
Figure 3. Prefabricated steel panels for underwater repair of Old River Low Sill Control Structure

- 11. Originally 3/4-in.-diam expansion anchor bolts were used to attach the first panel to the structure. Overnight, the gates directly upstream from the panel were opened, and by morning the panel was gone. The bolts on the upstream edge of the panel had pulled out of the concrete because of uplift forces from the flowing water. The nuts on the bolts in the end sill wall had worked loose from vibration, and the threads were stripped. The number of bolts was increased from 4 per panel to 8 through 16 per panel. Later the expansion anchor bolts were replaced by 1-in.-diam bolts embedded in polyester resin.

- 17. Eight months after the repair had been completed, an inspection showed that all the spoilers were missing, two panels were entirely missing, and several other panels were partially missing. A number of anchor bolts were found broken either flush with the panel, flush with the grout, or pulled completely out. The fiber-reinforced grout was generally in good condition. It was adhering well to the base concrete, and the worst locations showed abrasion to a depth of 6 in.

- 18. Two years after the repair, an inspection showed 12 more panels either fully or partially missing. The grout was in good condition. Also the stilling basin was free of rocks and other debris; so apparently the rocks were being flushed from the basin.

- 19. Annual inspections were conducted after the initial repair and appropriate repairs made. In 1984, eight years after the initial repair, the majority of the steel plating and anchor bolts were gone, and there was erosion and spalling of the fiber-reinforced grout surface.

- 9. The control structure could not be completely shut down; so repairs were made under flow with some gates closed to produce acceptable underwater working conditions. The repair method used steel plates to cover the entire area between the downstream baffle blocks and the end sill wall. The plates sloped up from the basin slab behind the baffle blocks to the top of the end sill wall. The design modification allowed rocks to wash out of the stilling basin. Hydraulic studies showed that the modification was acceptable.
